# I-35W & Mississippi River Bridge Anti-Icing Project

## Operational Evaluation Report

Report # 2001-22

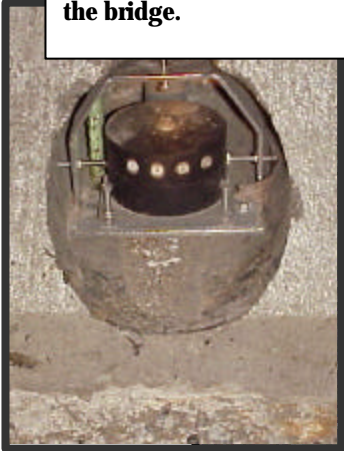
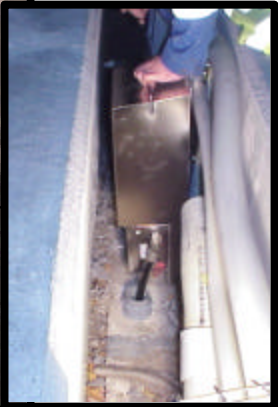
**Parapet Nozzle:**  
8 parapet spray nozzles mounted in the right and left J barriers, both travel directions located at the north end of the bridge.

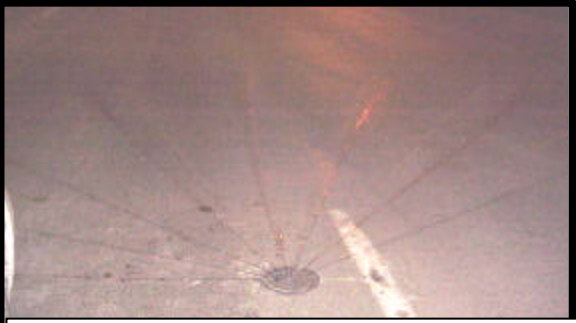
FIGURE 2 ANTI-ICING SYSTEM COMPONENTS

**Disk Nozzle:**  
68 flush mounted disk spray nozzles, spaced @ 55' on centerline of each direction of travel.

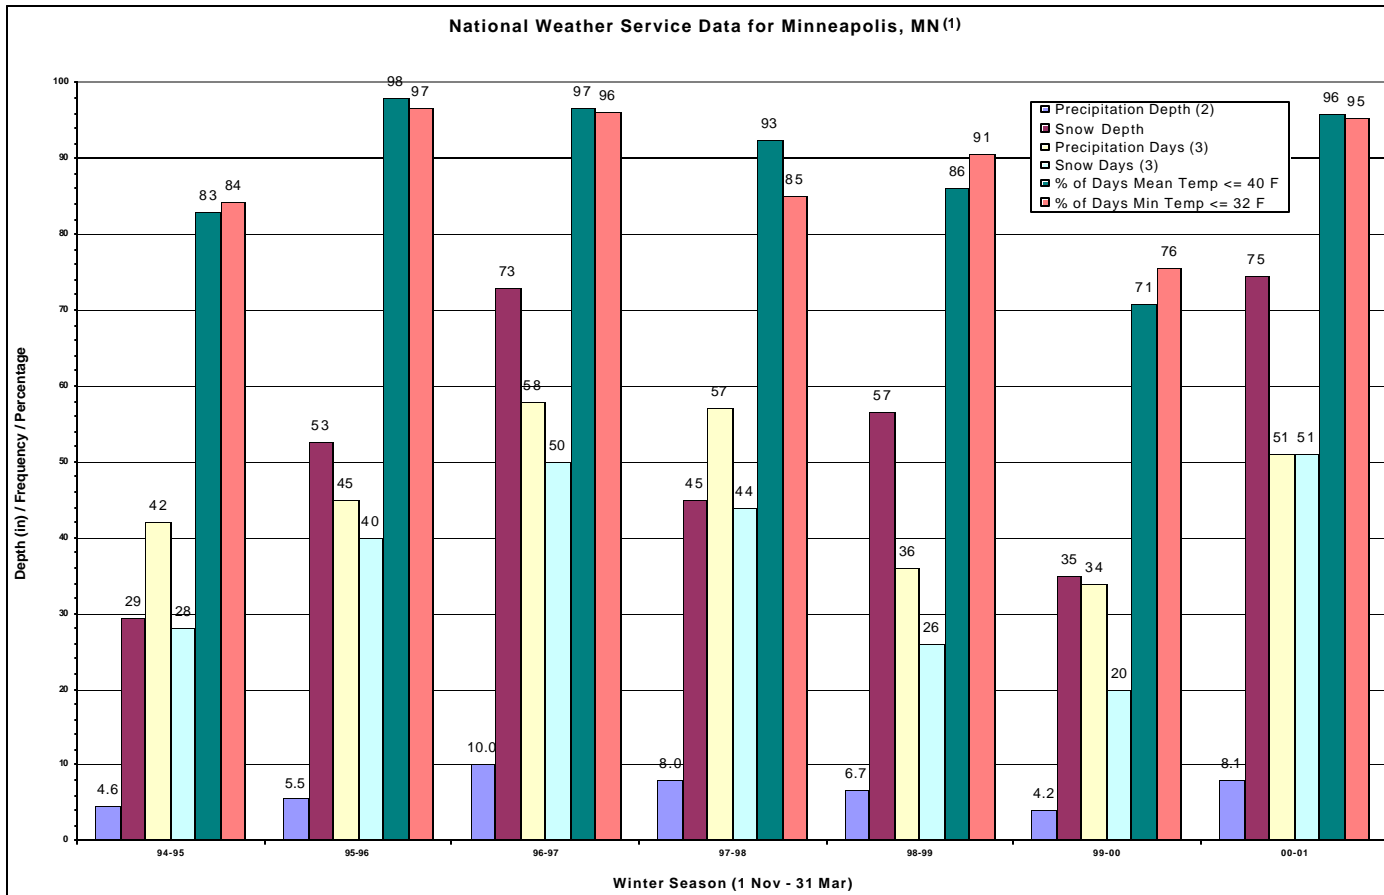
FIGURE 3 COMPARISON OF WINTER SEASONS

Notes: (1) All National Weather Service (NWS) weather data for Minneapolis is measured at Minneapolis-St. Paul International Airport for all winter seasons except 2000-2001. Data for 2000-2001 snow depth and days measured at NWS office in Chanhassen, MN  
 (2) Precipitation depth is the water equivalent depth of all precipitation types measured  
 (3) Precipitation and snow days includes only those days where measurable depths were recorded. Days where trace amounts were recorded are not included.

The data in Figure 3 that best represents the potential for adverse winter weather road conditions are precipitation days, snowfall days, and percentage of days with minimum temperature less than or equal to 32°F. In general terms, these three elements define the relative daily potential of either freezing precipitation occurring or precipitation freezing on road surfaces. Figure 3 shows a close match in these three important data categories for the 1995-1996, 1996-1997, and 2000-2001 winter seasons. Figure 4 consists of the three important data categories for each of the three winter seasons identified above, and further illustrates the strong similarities in weather severity between them.

Although no two winter seasons can be identical, the conclusion that can be reached from examining Figures 3 and 4, in combination with Table 3, is that the 1996-1997 winter season is, in fact, the most appropriate winter season for comparison to 2000-2001, with the winter season of 1995-1996 being a close second.

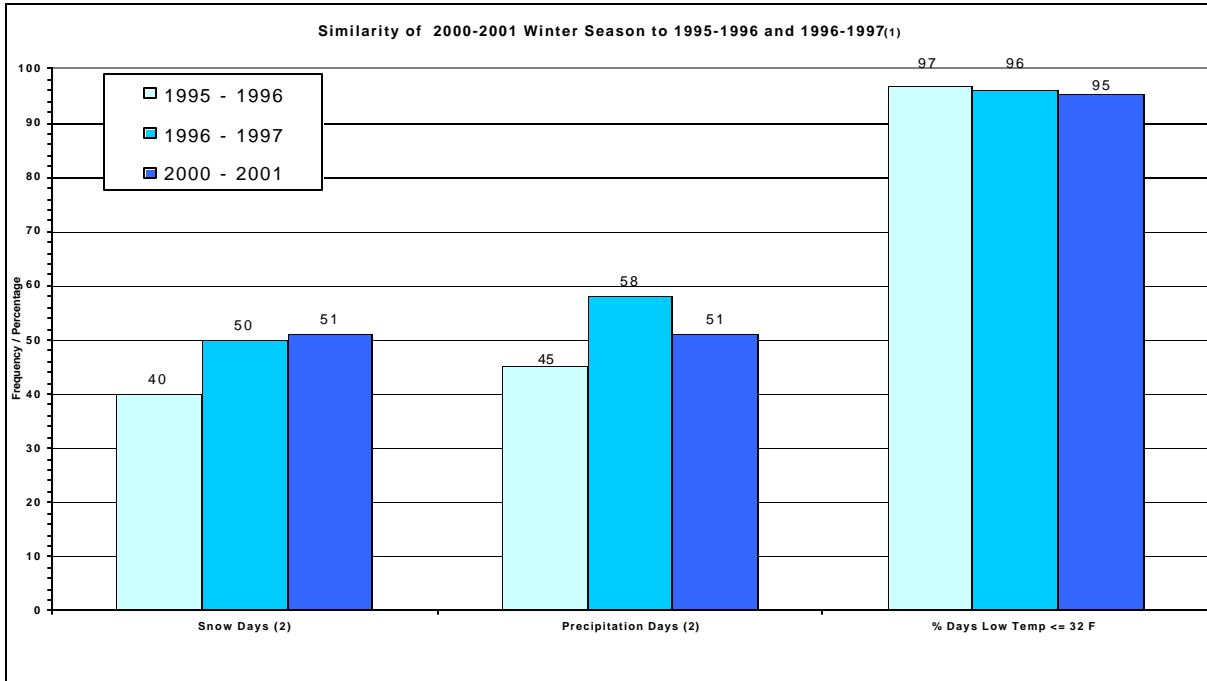
FIGURE 4 SIMILAR WINTER SEASON COMPARISON

Notes: (1) All National Weather Service (NWS) weather data for Minneapolis is measured at Minneapolis-St. Paul International Airport for all winter seasons except 2000-2001. Data for 2000-2001 snow days measured at NWS office in Chanhasseen, MN.  
 (2) Precipitation and snow days includes only those days where measurable depths were recorded. Days where trace amounts were recorded are not included.

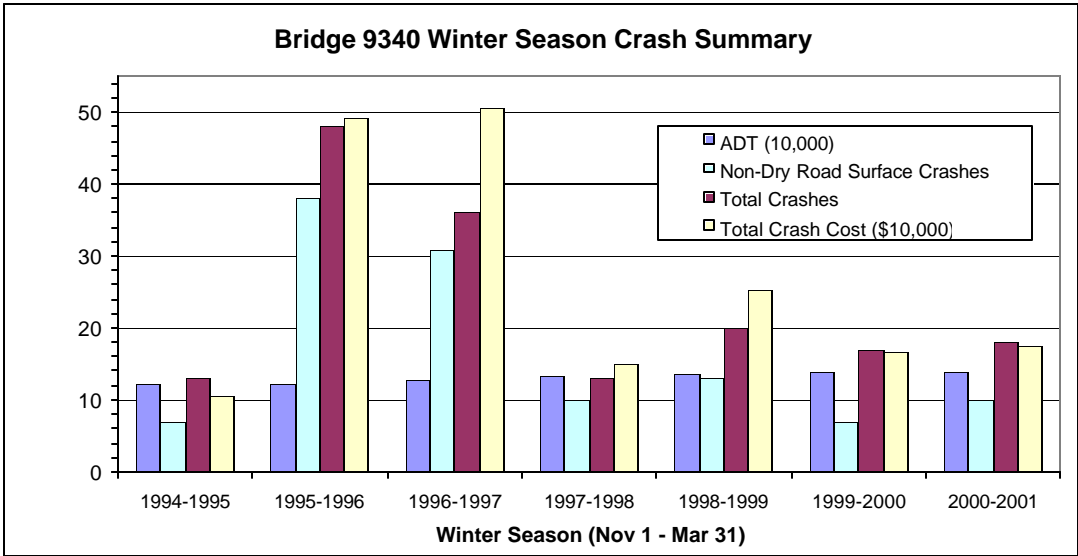
FIGURE 5 TIS CRASH SUMMARY

Figure 5 highlights the significant decrease in total crashes for the 2000-2001 winter season when compared to the 1995-1996 and 1996-1997 winter seasons. Included in this figure is a separate entry for the total number of crashes in each season where the road surface condition was coded in TIS as anything other than dry. The road surface was coded as dry for 49 of the 165 total crashes. The remaining 116 non-dry road surface crashes includes 28 coded as wet, 11 coded as snow/slush, 76 coded as ice/packed snow, and 1 coded as debris. The single use of the misc. code was for a crash where the enforcement officer's and one driver's report described the debris involved as ice on the road surface. NWS weather data for MSP shows that 93.0% of the time freezing temperatures were recorded at or near the time of all non-dry road surface crashes. For just those non-dry crashes with the road surface coded as wet, freezing temperatures were recorded 77.8% of the time at MSP. No attempt was made during the study to correlate bridge deck (surface) temperatures to those recorded

The TIS crash data for the bridge shows that a significant reduction in crashes occurred with the automated anti-icing system installed and functional on the bridge during the recent winter season as compared to previous winter seasons with similar weather conditions. **This reduction is approximately 68%** (31 non-dry crashes in 1996-1997, 10 in 2000-2001). Since the automated system provided the vast majority of preventive and corrective treatment of the bridge deck, it can be said that this tangible reduction in non-dry road surface crashes is primarily the result of the performance of the automated system. As evidence, dry road surface crashes did not change in any significant manner because they are not linked to the weather conditions and thus the method used to provide road surface snow and ice maintenance.
